## OCCUPANT KINEMATIC ANALYSIS OF AN UNBELTED MINIVAN PASSENGER: A FREE BODY APPROACH

David E. Raymond, Edward C. Fatzinger Jr., Thomas J. Connors, Jeffrey B. Wheeler  
Vector Scientific, Inc., Los Angeles, California  
[draymond@vectorscientific.com](mailto:draymond@vectorscientific.com)

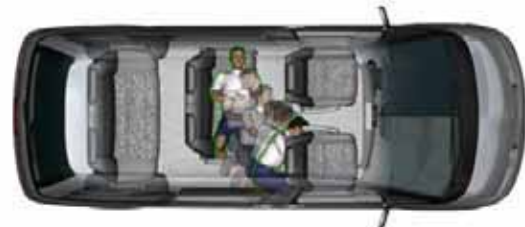
This trajectory was used to then render a 3-D drawing of occupant motion relative to vehicle interior components.

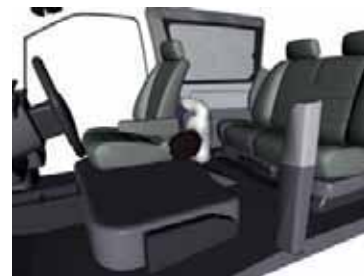
An 11-14 inch offset existed between the top of the bench seat and the bottom of the passenger side second row window. 3-D analysis revealed that the occupant would not have ejected out of the side window but rather contacted the front passenger seat as shown below. This is mostly due to the rotation of the minivan upon impact. The occupant is shown in a position close to the floor of the van which is an effect of both gravity and ramp effect of the seat back. The occupant presented with a facial laceration to the right cheek that coincided with contact of the right front seat inboard armrest as shown below.
