## INITIATION AND PROPAGATION OF FATIGUE MICROCRACKS FROM A DEFECT IN A CEMENTED TOTAL HIP ARTHROPLASTY

Jihui Li<sup>1</sup>; Gang Qi<sup>1,2</sup>

<sup>1</sup>Dept. of Biomedical Engineering, <sup>2</sup>Dept. of Mechanical Engineering. The University of Memphis, Memphis, TN 38152  
E-mail: [jihuili@memphis.edu](mailto:jihuili@memphis.edu) Web: [http://www.me.memphis.edu/mar\\_lab/mar\\_lab/home.htm](http://www.me.memphis.edu/mar_lab/mar_lab/home.htm)

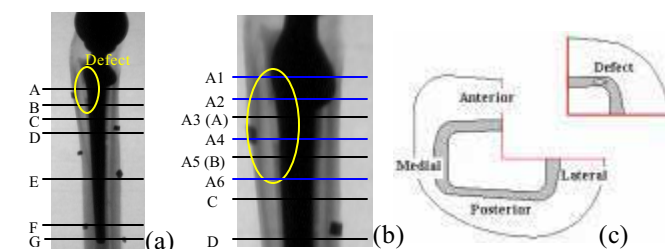
A series of standard hand mixed cemented THA specimens were prepared using Spectron stem, Palacos R cement and Sawbone femurs. In X-ray examination, one specimen with a proximal defect of  $6.5 \times 2.5 \times 14.0$  mm (in anterior-posterior, medial-lateral and distal-proximal direction, respectively) was identified (Fig. 1a) and selected to study the influence of the defect on MCs activities. The specimen was subjected to 5 million cycles of fatigue loading (267/2670 N at 2 Hz) on a MTS machine. MC signals were detected by an AE system and their locations were calculated. Six virtual sections (A1 to A6, 5 mm thick each) were selected from the defect area (Fig.1b). MCs that occurred in each section were counted and plotted onto the anterolateral quadrant (Fig.1c) to visualize the initiation and accumulation of MCs (a process called AEMG [3]). After the experiment, the specimen was sectioned at seven locations (A-G in Fig.1a) for SEM inspections.

**Fig. 1.** (a) X-ray of the specimen, sectioned at A to G. (b) Six virtual sections (A1 to A6). (c) Anterolateral quadrant of A3.

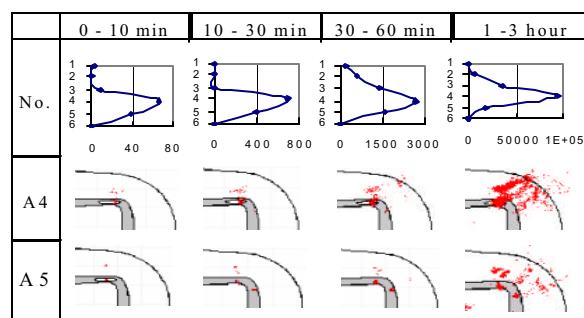
The AEMG and the number of MCs of virtual sections in the first three hours (Fig.2) indicated that the fatigue damage initiated from the lower lateral end of the defect (section A4) 4 seconds after test started. The damage spread to the surrounding area of the defect (A2-A5) immediately and the number of MCs increased dramatically. Damage propagation (evaluated by number of MCs) decreased as the test proceeded, but with three recover periods which started from the 12<sup>th</sup>, 18<sup>th</sup> and 22<sup>nd</sup> days, respectively (Fig. 3c). Most MCs accumulated around the middle-lower defect (A3-A5). SEM observed a continuous debonding at cement-stem interface next to the defect at physical section A (Fig.3a). A large amount of cement debris could be identified in the debonding (Fig.3b). This indicated the MCs in the middle and final fatigue process was caused mainly by the grinding between damaged interfaces instead of the damage propagation. No MCs located along cement-bone interface and on either side of the defect. Few insignificant MCs were detected in other physical sections.

**Fig. 2.** Number of MC cumulated in A1 to A6, (represented by 1 to 6) and their distribution (A4 to A5) in the first 3 hours.

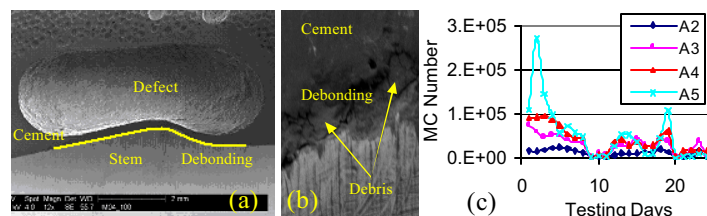
**Fig. 3.** (a) ESEM image of the defect with debonding marked by yellow curve (12 $\times$ ). (b) Details of the debonding (333 $\times$ ). (c) Number of MCs occurred in A2 to A5.
