## OCCUPANT KINEMATIC ANALYSIS OF AN UNBELTED MINIVAN PASSENGER: A FREE BODY APPROACH

David E. Raymond, Edward C. Fatzinger Jr., Thomas J. Connors, Jeffrey B. Wheeler  
Vector Scientific, Inc., Los Angeles, California  
[draymond@vectorscientific.com](mailto:draymond@vectorscientific.com)

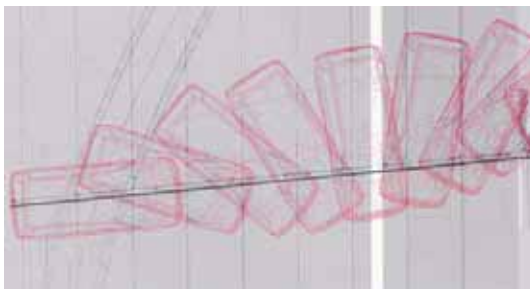
Vehicle kinematics were used to establish the pre-impact heading of the unbelted second row occupant. Since the occupant was unbelted the assumption was made that the second row occupant would act as an uncoupled body in the crash and continue along his pre-impact heading until acted on by an interior vehicle component. Once the heading was determined, the occupant position at coincidental time intervals as the vehicle dynamics data was determined and plotted. Once this was done the two are merged to give gross occupant kinematics assuming no interior contacts. Offset of the occupant initial position was made based on testimony of the occupant and interior vehicle measurements of the second row bench seat.

Once this was done, the coordinates were transformed into the vehicle coordinates system.

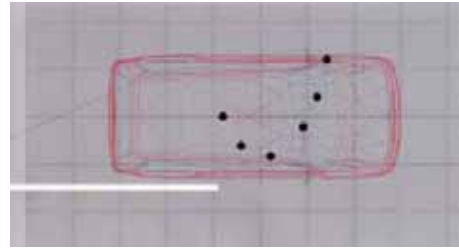
This trajectory was used to then render a 3-D drawing of occupant motion relative to vehicle interior components.
